Investigating the effectiveness of earthquake risk reduction strategies for readymade garments industry occupants in Chittagong, Bangladesh

The project 00084327 Sharing and Learning on Community Based Disaster Management in Asia (Phase II)

Dr Edris Alam

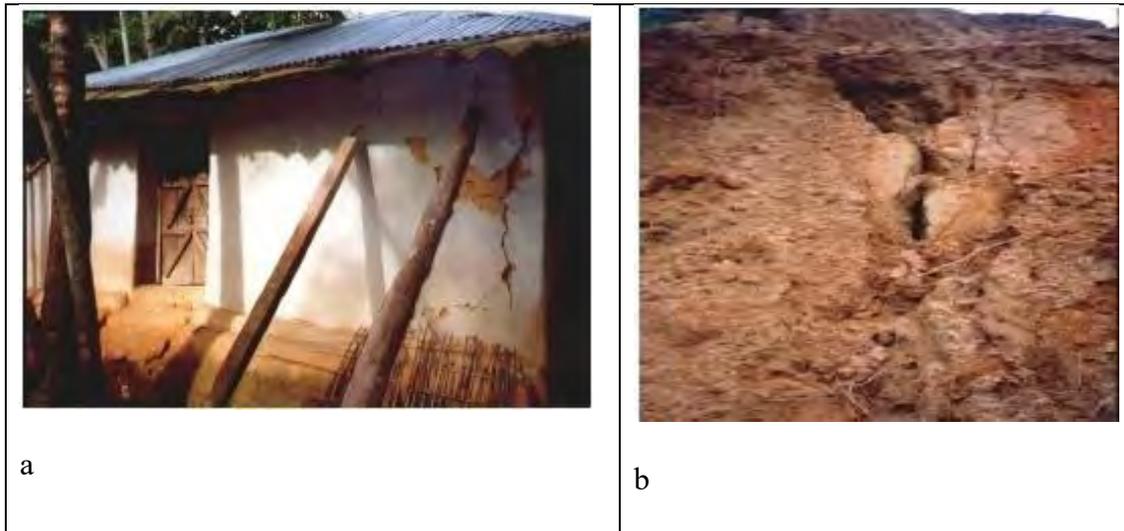
earthquake killed 7 people (Alam et al., 2006) and injured several hundred people (Ansary et al., 2000). Cracks developed in an earthen embankment surrounding the island. Cracks developed in a hill slope (Fig. 4b) and the earthquake triggered several landslides.

Figure 4: The effects of the 1999 earthquake in the Moheskhali Island: a) Cracks in a mud wall in Moheskhali Island by the earthquake, b) Cracks in a hill slope in Moheskhali Island by the earthquake (Source: Ansary et al. 2001).

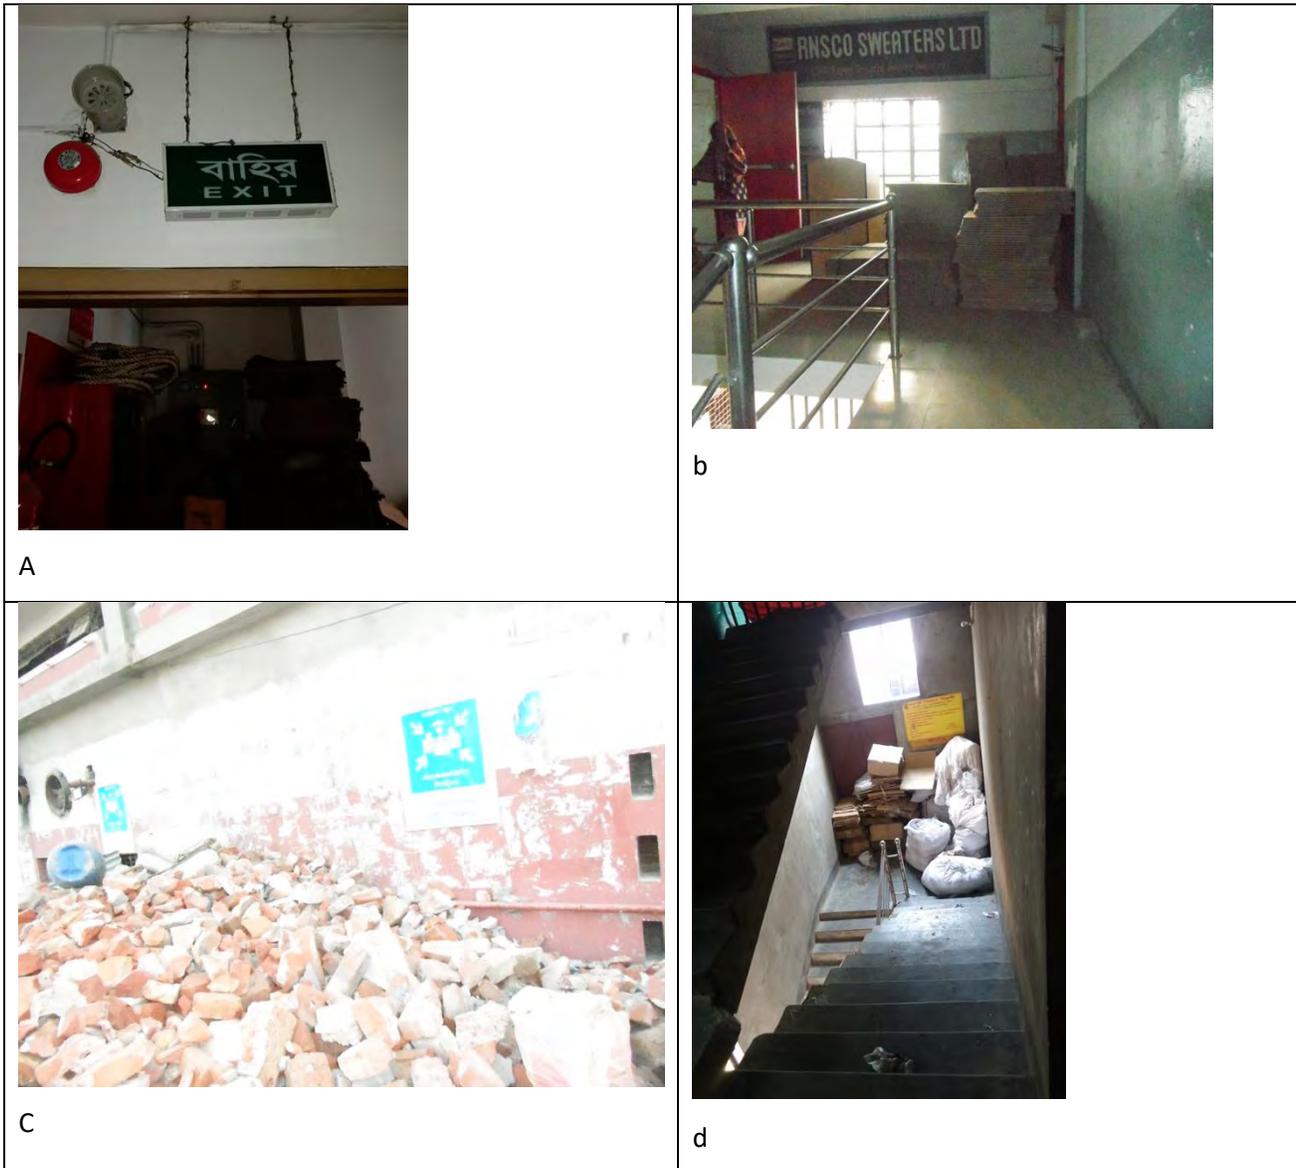
Some industry management claimed that they have highest preparation to mitigate fire and earthquake hazards. Key informant discussions with management authorities of the industries those who are highly compliance with workplace safety suggest that the structural design of the buildings and overall preparation are zero tolerance for any hazard. This resulting in at least 32 workers suggested that they do not have any evacuation problem in their workplace. They informed that they evacuate from the building in two minutes if any hazard alarm provided. Additionally, seven workers suggest that they could not understand about evacuation problem. The rest 139 workers provided multiple responses in relation to evacuation problem at their workplace (Table 21). These include: (1) the provision of the main entrance and exit on the ground floor that is not wide enough for the mobility of workers in the factory; (2) narrow exit gate; (3) passages, aisles, corridors, stairways are blocked by packages; (4) no fire door installed; (5) no exit sign; (6)blocked exit gate etc.

Ranking No	Evacuation problems	Frequency
1	The provision of the main entrance and exit on the ground floor that is not wide enough for the mobility of workers in the factory	73
2	Narrow exit gate than required	55
3	Passages, aisles, corridors, stairways are blocked by packages	38
4	No fire door installed	31
5	No exit sign	24
6	Blocked exit gate	21
7	Improperly illuminated exit sign	16
8	Locked collapsible gates on different floors	12
9	Fire door does not swing in the direction of travel	10
10	Lack of necessary gates	3
11	No extra stairs	2

Photo 2: Evacuation problems in RMG industries. a) Exit gate is blocked by boxes and other items; b) Stairways are partially blocked by hardboard; c) Brick items placed at Assembly Point; d) Stair ways are blocked by boxes and garbage items.
